PTP REPORT NO. 82-10
AFPA PROJECT NO. 82-10

PERFORMANCE EVALUATION OF METAL VERSUS NON-METAL ONE-QUART OIL CANS

HQ AFALD/PTP
Air Force Packaging and Evaluation Agency
Wright-Patterson AFB Ohio 45433

DECEMBER 1982

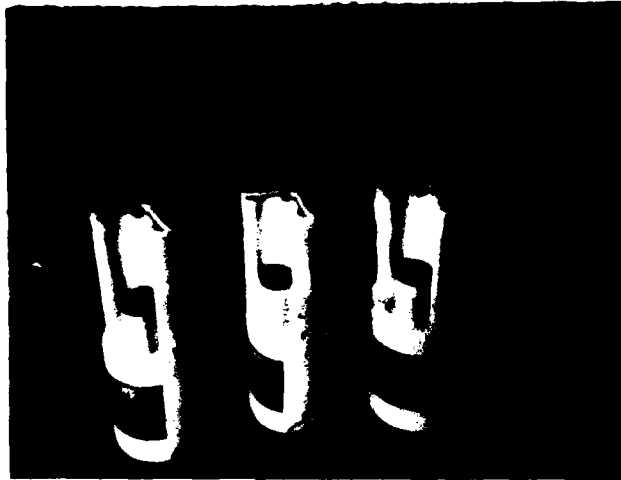
Note 19 - Level A, 21" drop height, ambient temperature: 3 cans leaked. Hairline cracks occurred in the center of the bottom, where the joining seam bridges a cavity designed in the base of the can. 2 caps were found loose in the case, however, the foil seal prevented an oil spill. Other damage was confined to the dents that occurred primarily at the base of the HDPE material (see picture below).
